The Hamptons at MetroWest, a Case Study of an Investigation Into the Causes For Structural Rot Damage

Felix Martin

Principal Engineer, Marcon Forensics, LLC, 2757 Victoria Drive, Laguna Beach, CA 925651; PH (949) 376-0290; FAX (888) 752-5580; email: felix@marconforensics.com

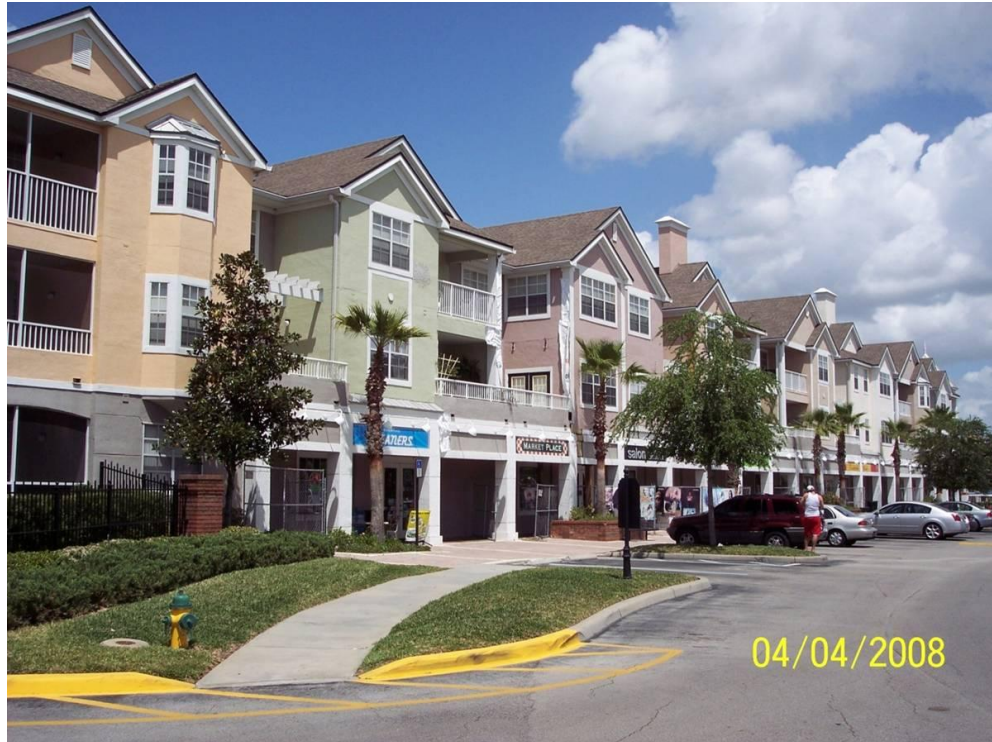
Photo 1 – Building 41 at The Hamptons.

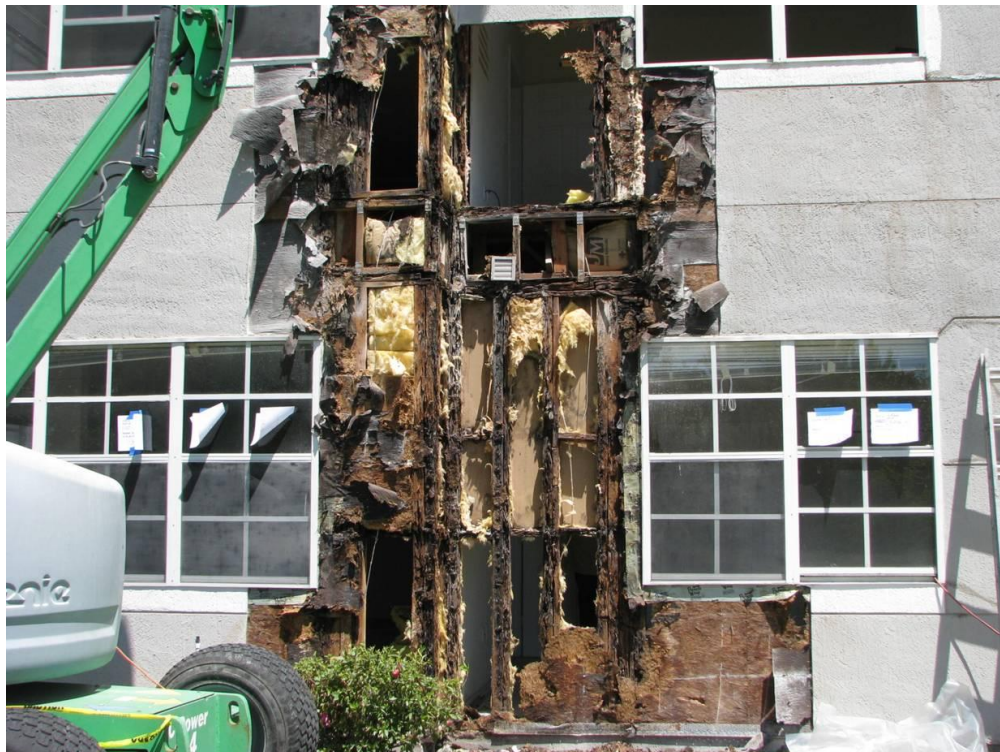
Photo #2 – Rot decayed wall framing.

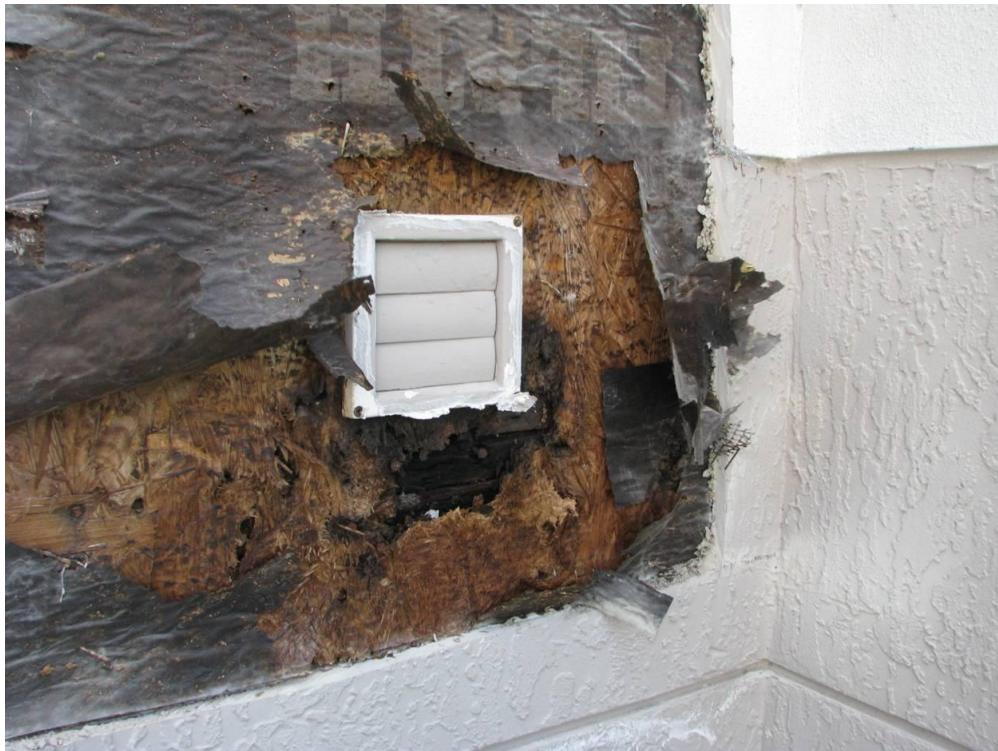
Photo #3 – Decay damage at un-flashed dryer vent.

- Flange-less dryer vents were installed without any flashing around the edges, allowing water to penetrate into the wall cavities.
- The exterior balconies' deck membranes were not continuously sealed along the edges, or had fasteners penetrating through them, allowing moisture to reach the wood substrate.

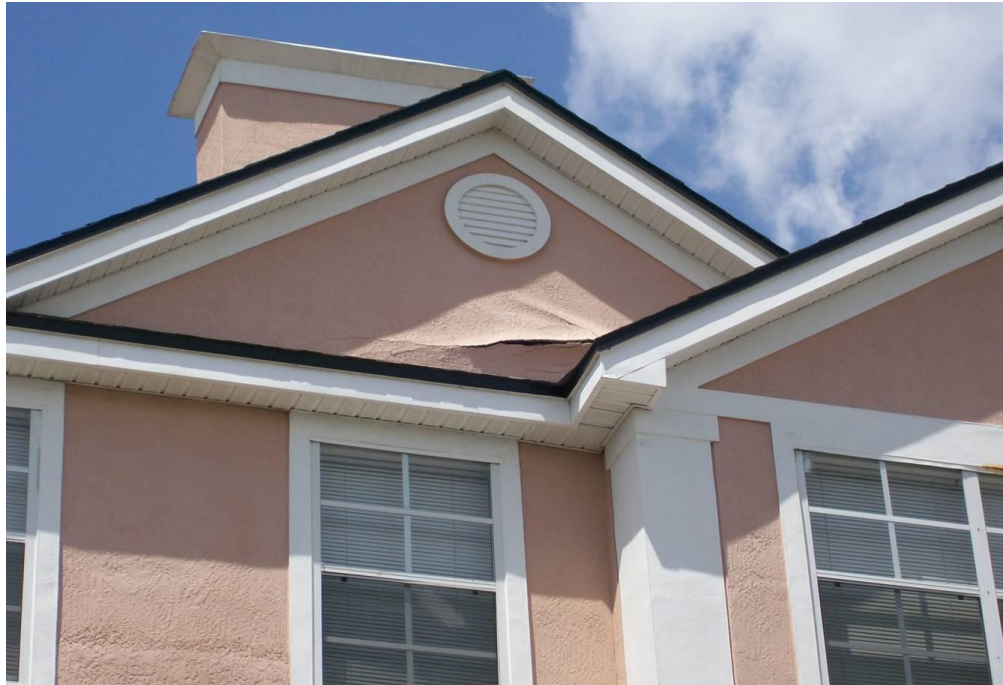
sections of stucco that had either through poor anchoring of the lath to the framing or because of the decayed nature of the wood substrate, become detached from the building and were threatening to collapse.

Photo #4 – Stucco detaching from building.
